REPORT OF MECHANICAL SURVEY

“MV XXX”

1987 Bayliner Pilothouse MY 4550

Report file no: CWS-4-2011

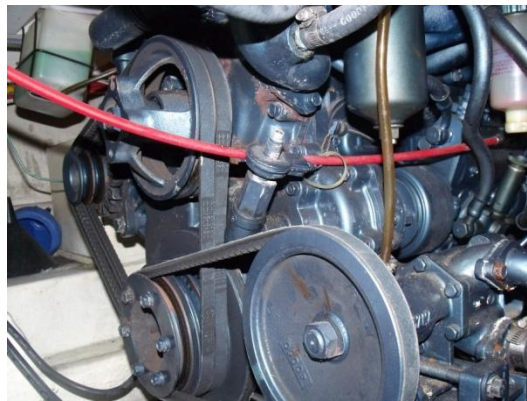
(1) The throttle cable for the starboard engine is not secure and has been run thru the belt and pulley area of the engine (see photo). RECOMMEND: Secure throttle cable to prevent it from possibly coming in contact with engine belt and causing failure of belt and/or throttle cable.

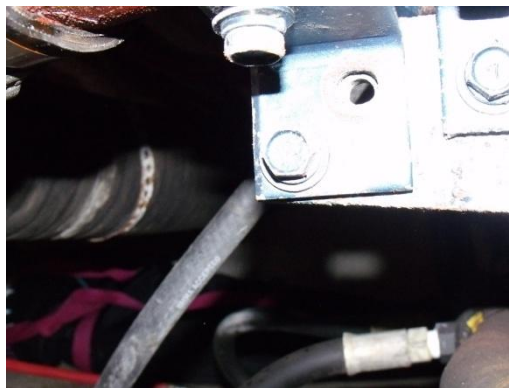
(6) The mounting bracket for the port engine exhaust riser is missing a fastener (see photo). RECOMMENDATION: Install fastener of proper size.
