Zenith Maritime LLC

10 May 2009

Re: ZM 09-90XX - Marine Survey of Cumulant 38 Underbody for Condition and Serviceability

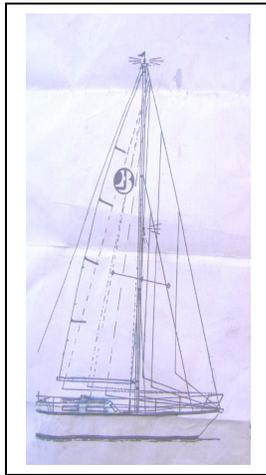
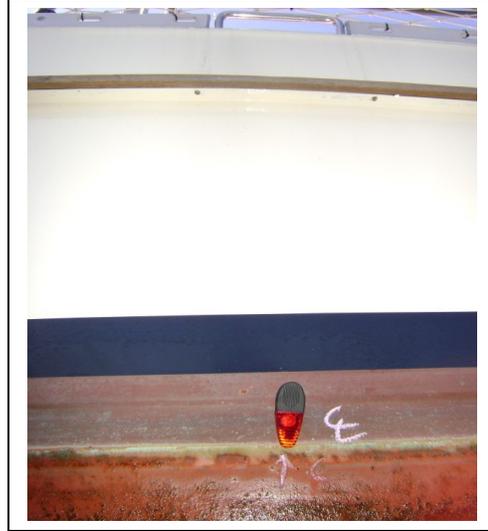
Side profile of the subject vessel, a Cumulant 38 (left) – Station number 7 referencing deck mounted cleat above red colored clip (right).

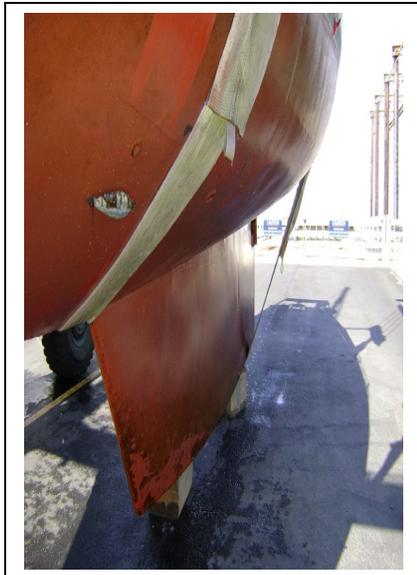
Upon visual examination – the surface of the hull and keel showed no rust blooms, pitting, corrosion, fatigue, structural failure, and or wastage and was fair to the eye with no hard spots or proud plates. Minor inward hull plating buckling was observed below the water line - portside to at the lower underbody and keel at the frame bays. Minor buckling was also observed sporadically starboard side to. Welded plate seams were observed to be in serviceable condition with no visual cracks - fractures or corrosion. Welded in place through-hull penetrations were thoroughly examined – again with no visual evidence of wastage or fatigue. Sacrificial zinc anodes are properly attached to the steel hull plating and at the propeller tail-shaft. The keel shoe was found to be smooth and unabraded. The leading edge of the keel and stem showed no evidence of damage or abrasion.

Portside hull underbody just after the vessel was hauled – hull surface clean and smooth. Slight inward buckling at the turn of the bilge and at keel (left). Starboard hull was similarly unremarkable (right).

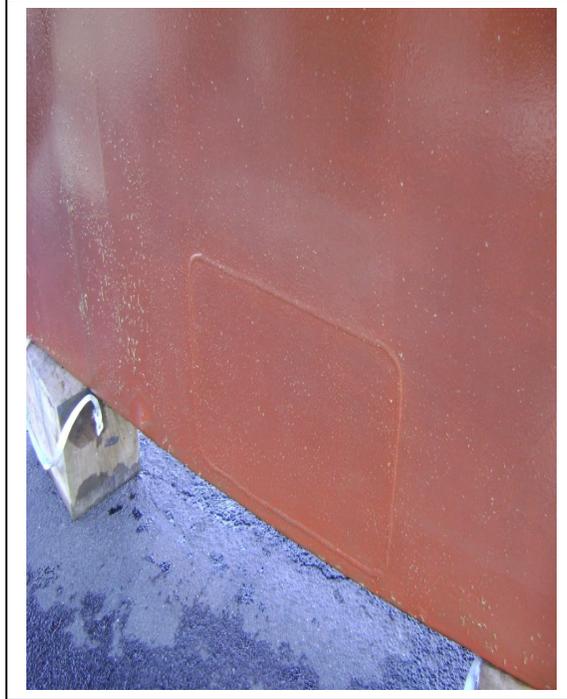
Replaced access plate found lower against the keel shoe on the portside.
